DOCKET NO. SA-228

EXHIBIT NO. 20A

CARGO/FIRE GROUP CHAIRMAN'S FACTUAL REPORT

Accident Number: DCA06MA022
Operator: United Parcel Service Company
Location: Philadelphia International Airport (PHL), Philadelphia, PA
Date: February 7, 2006
Time: 2359 Eastern Standard Time (EST)
Airplane: DC-8-71F, N748UP

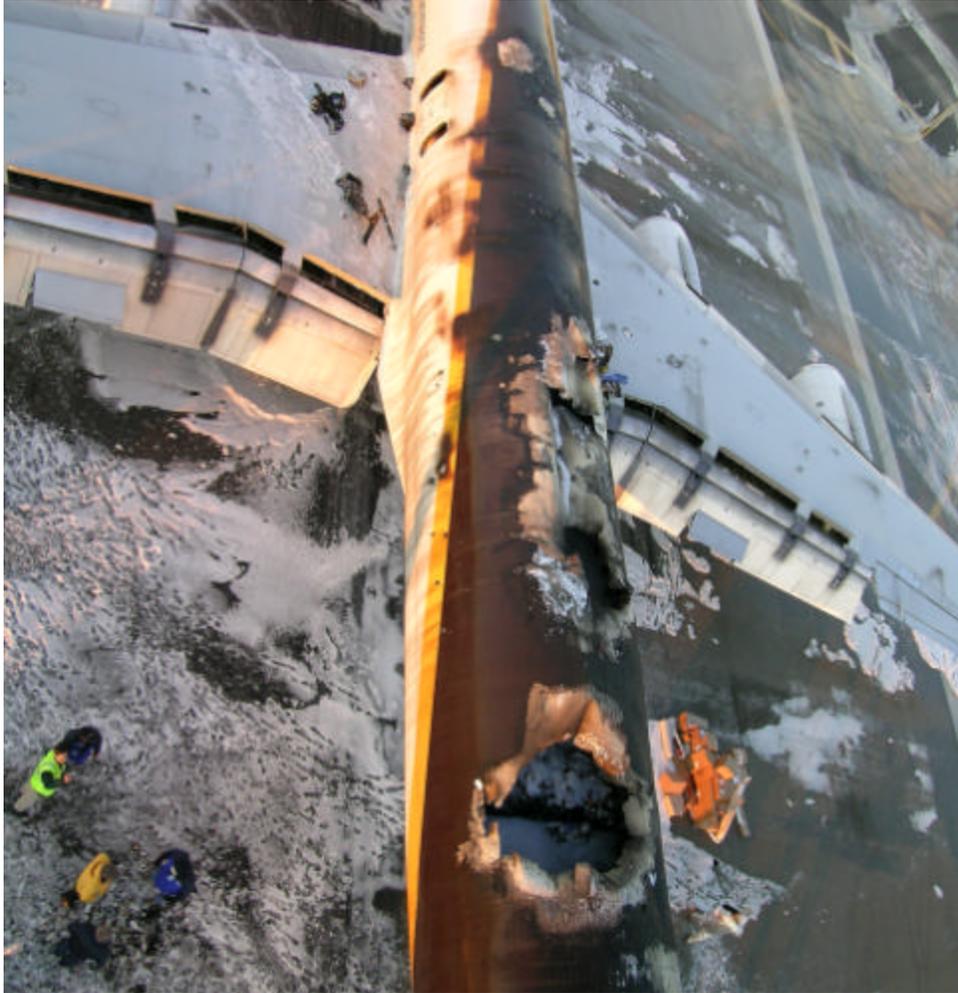
There were two burn through holes in the crown of the fuselage. There were also two areas of partial burn through, one located in the crown and one located on the right side of the aircraft aft of the wing.

Figure 1: Overall of damage to crown.

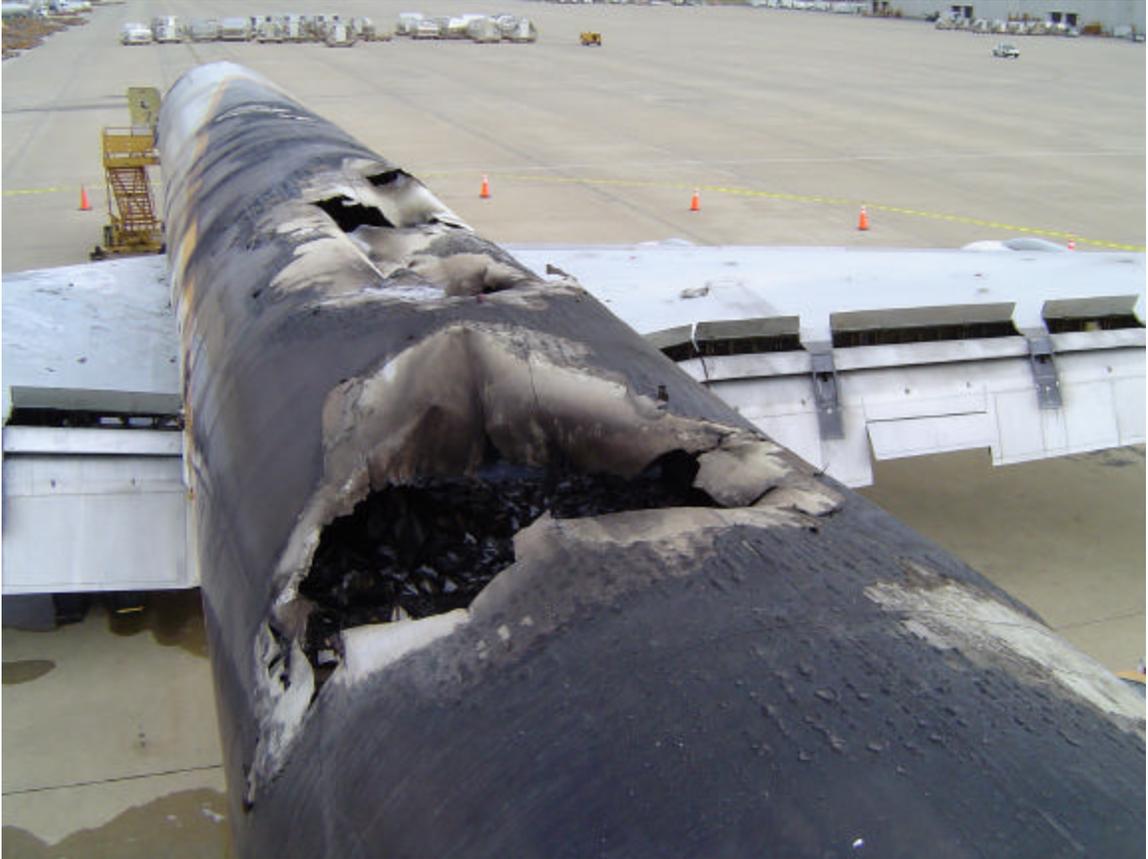
On the exterior of the aircraft, the exterior paint was intact on most of the aircraft with the exception of the areas surrounding the two burn through holes in the crown where the paint was gone from the remaining structure. The paint was bubbled and darkened at the crown over the wings. There was sooting around the Crew Forward Entrance door, the four overwing exits and the Right Aft Service door. The paint around the outflow valve was heavily sooted and slightly bubbled. There was no other significant exterior damage on the aircraft.

Figure 2: Burn through holes in crown of the aircraft (facing forward).

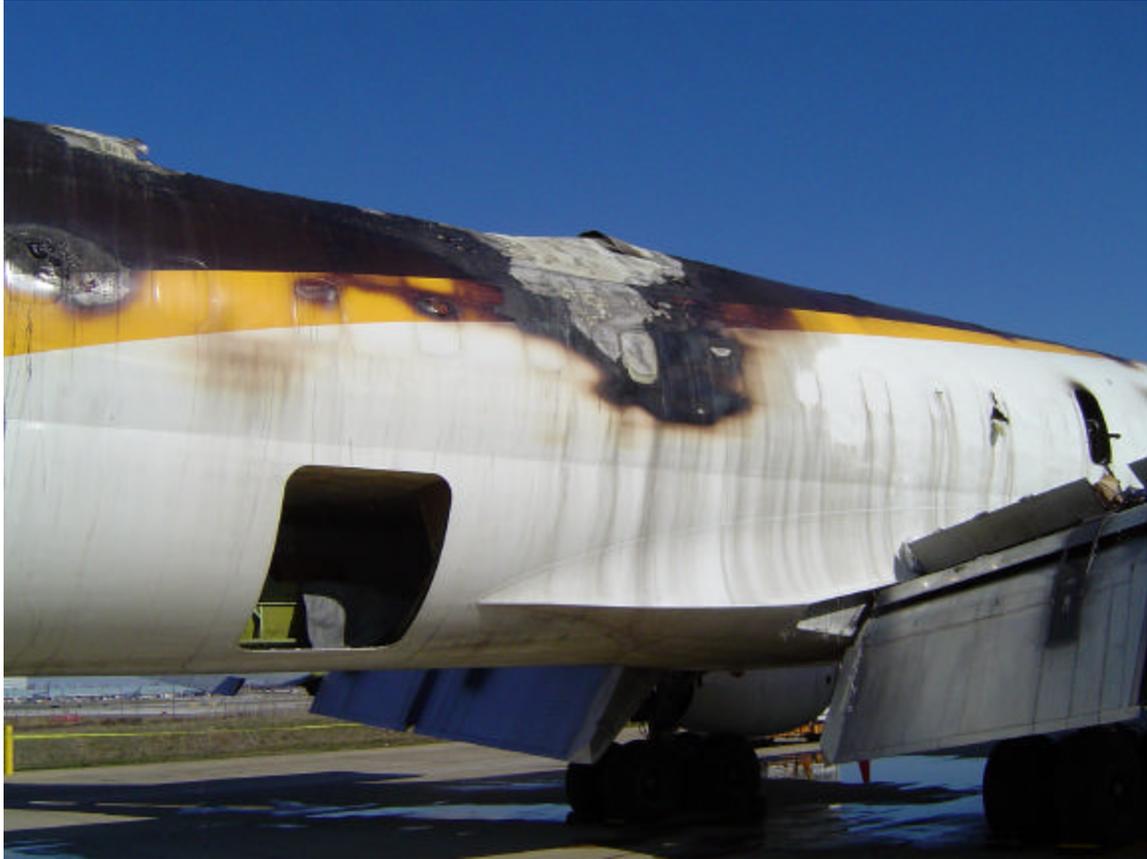
Figure 3: Damage to exterior of aircraft (right side).

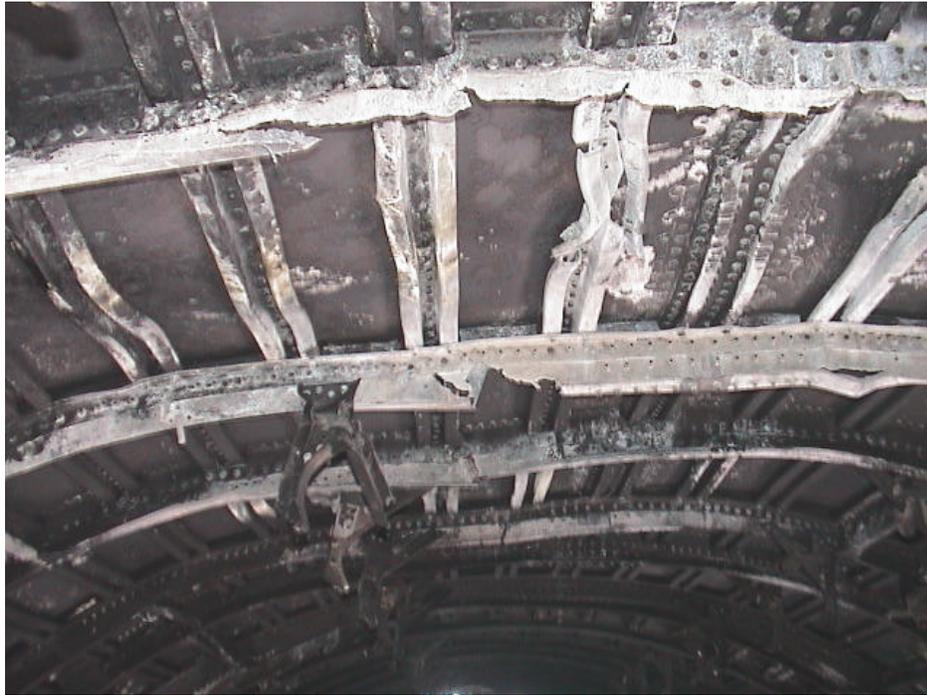
At FS 702.875, FS 717.750, FS 742.250, FS 759.000, FS 781.500, the structure was sagging, bent and white in color. Partial frames were present on longeron L-6 on the left to L-6 on the right side.

Figure 5: Overhead at Position 8 (Approx. FS 730).

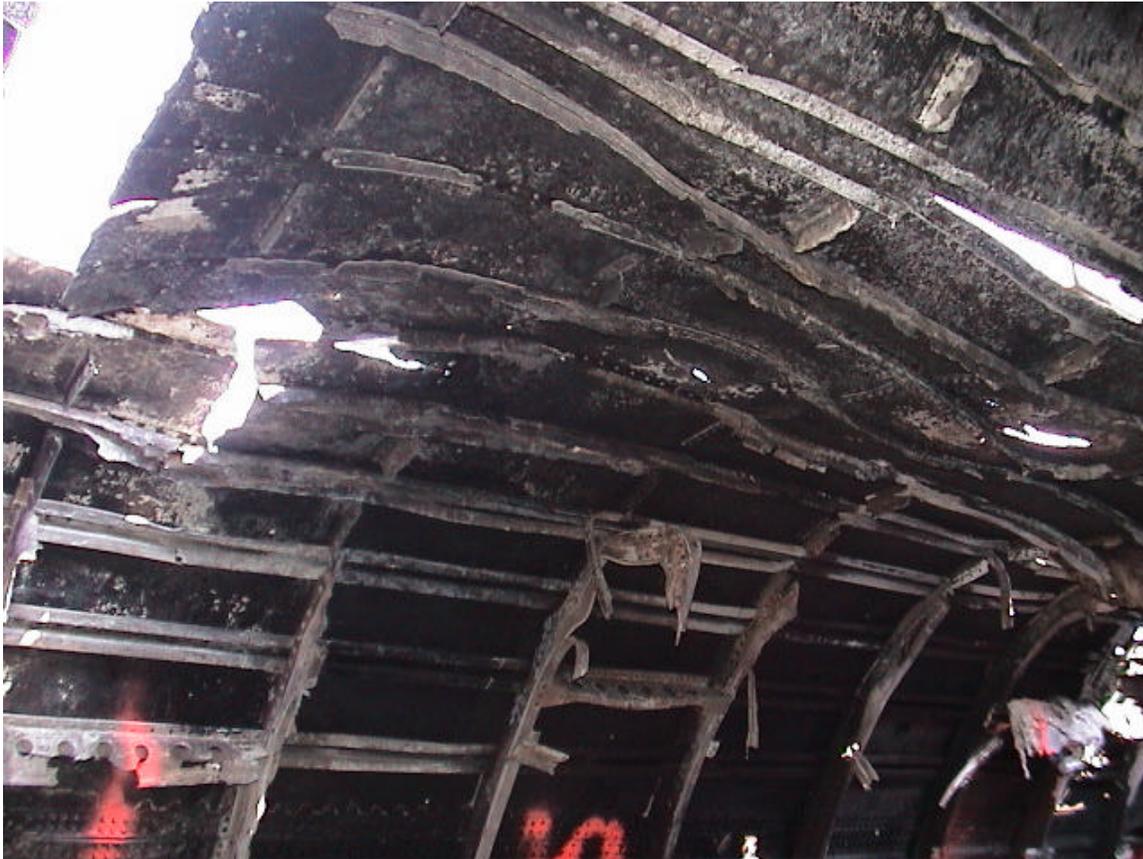
frame was present from L-1 to L-7 on the right side. From FS 1080.000 to FS1200.00, there was a partial frame from L-1 to L-7 on the left side. The frame and longeron were gone and the skin was collapsed inward from L-1 to L-7 on the right side.

Figure 6: Sagging structure located above Position 13 (Approximately FS 1174).

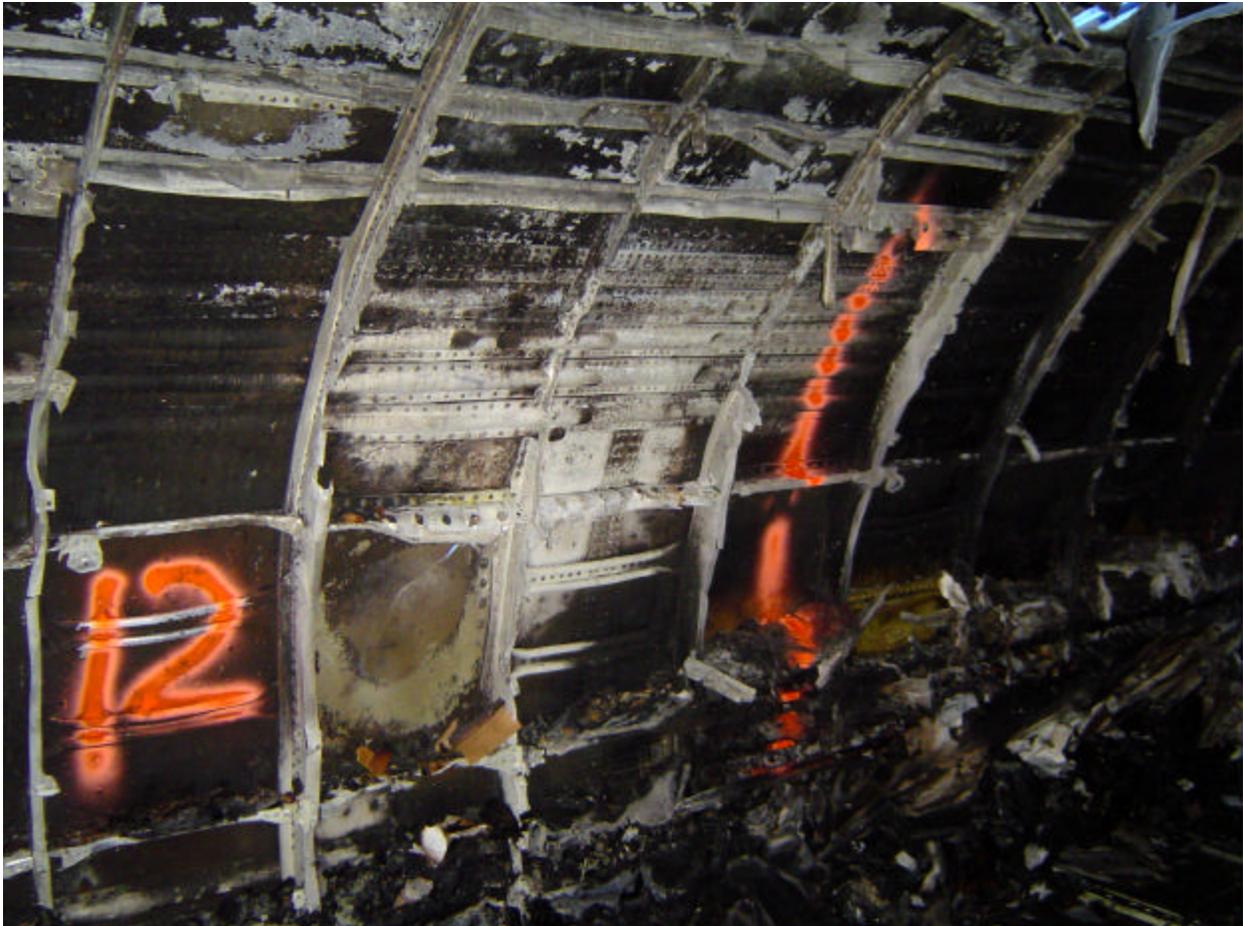
At FS 1040.000, the structure was sagging and a partial frame was present from L-1 to L-3 and L-9 to L-11 on the left side and L-1 to L-9 on the right side. At FS 1060.000, skin, frame and longeron deformation was present on the left side. There was partial skin burn through, and a partial

Figure 7: Partial skin burn-through at FS 1060 (Position 12 right).

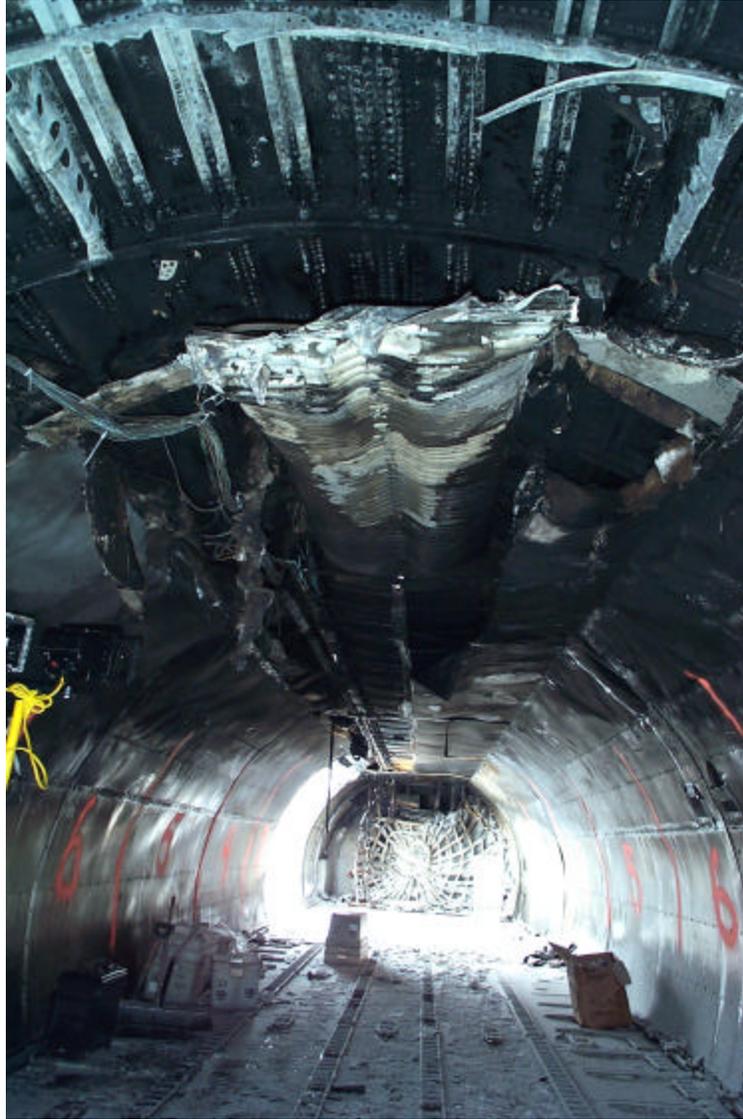
Air was supplied to the main deck cargo compartment from a ventilation duct that ran down the centerline of the compartment above the ceiling liner. Supply ducts extended from the center duct to air inlet grills located on the outboard section of the ceiling liner on both the right and left sides of the interior of the fuselage. The supply ducts and inlet grills were present at approximately FS 345, 468, 550 and 670. The main ventilation duct, supply ducts, and inlet grills were all missing aft of FS 670.

Figure 8: Damaged ventilation ducting at FS 670 (Position 7).

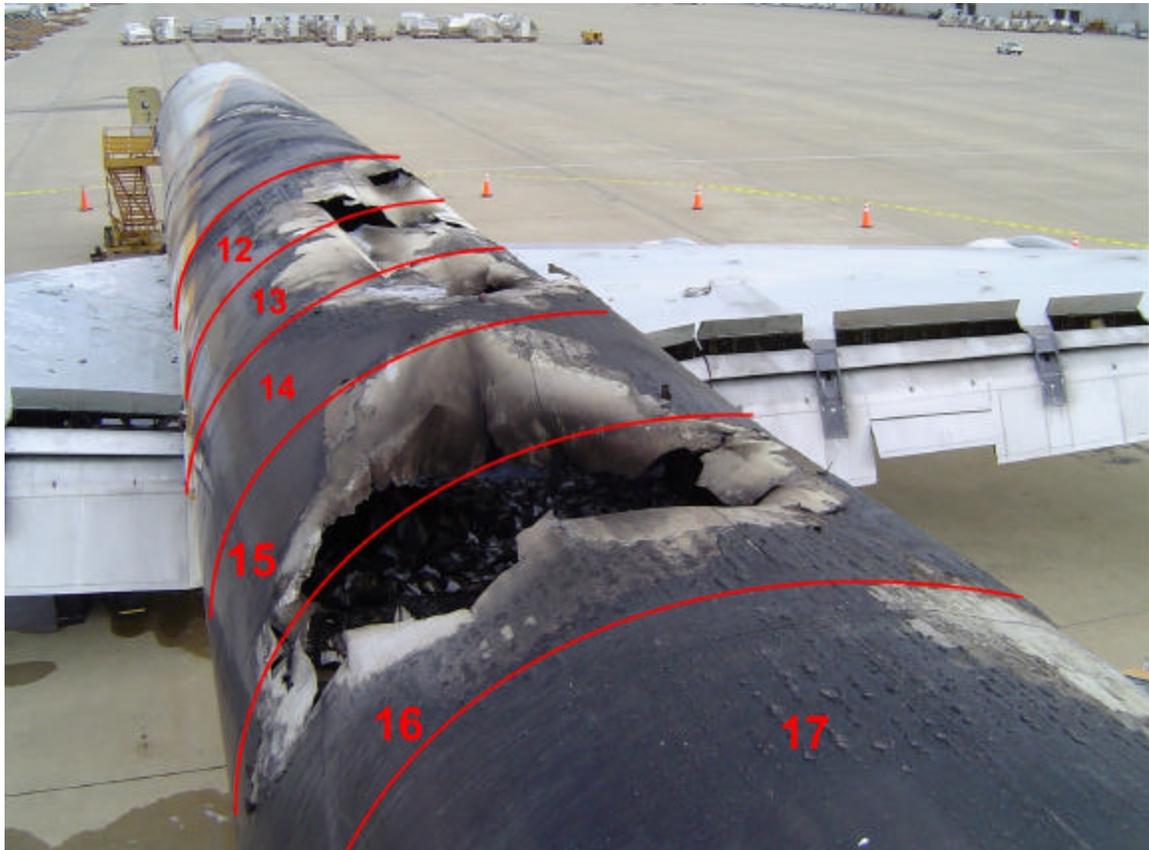
Figure 9: Crown burn-through with corresponding ULD position numbers.

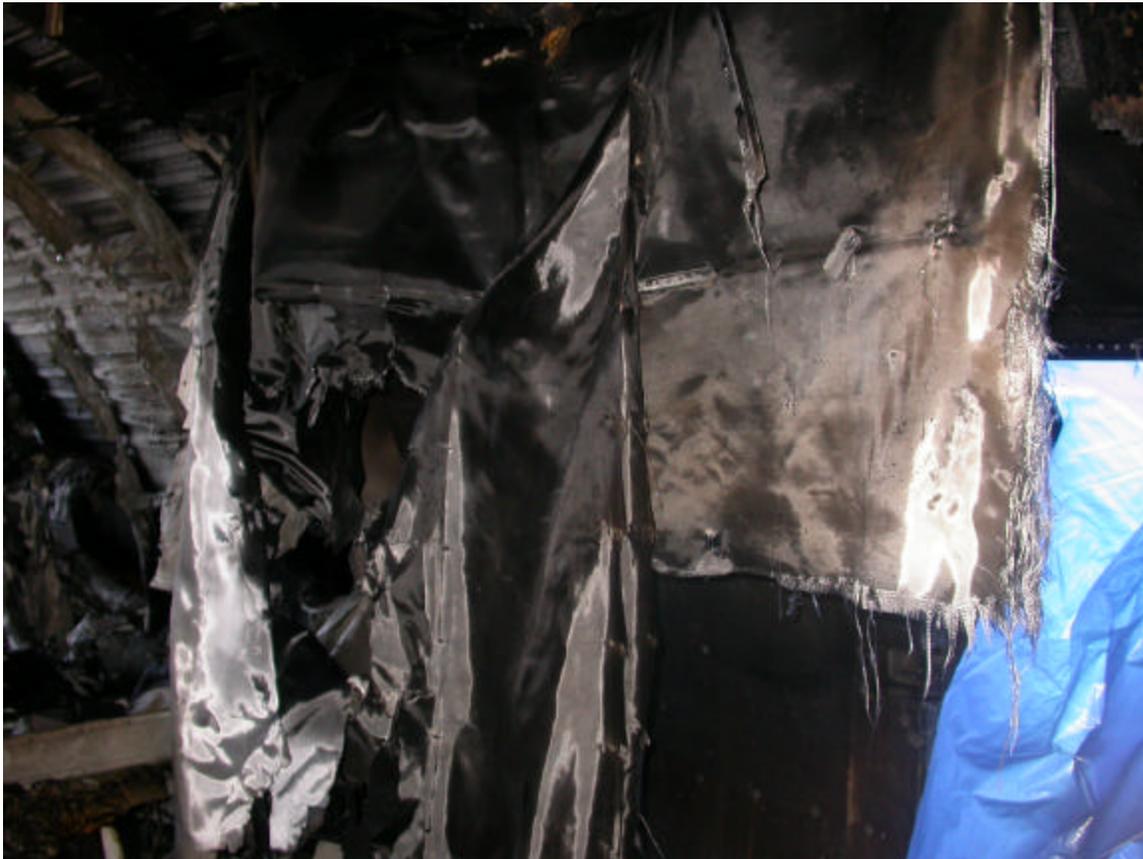
Figure 9: Cargo liner at Position 18.

At Position 18 the ceiling liner was missing. The upper ¼ of the left sidewall exhibited burned resin and the lower left sidewall was sooted. The resin in the upper ¼ of the right sidewall was burned, and the lower right sidewall was sooted.

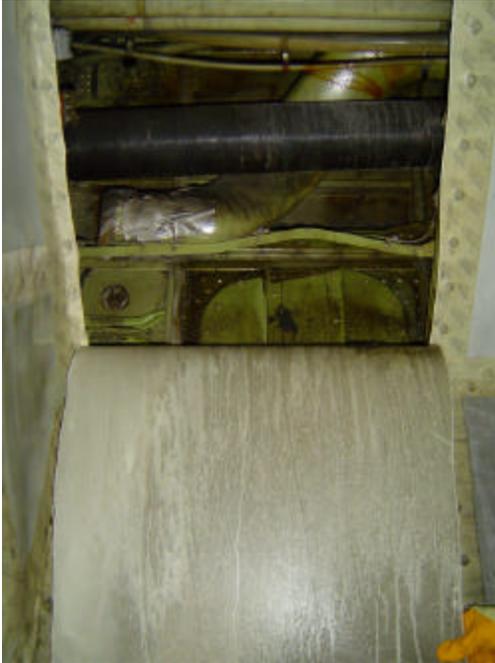
Figure 10: Check area Pit #31.

In this pit, various locations behind the liner were examined to determine if there were any signs of fire propagation. Dirt, lint, anti corrosion agent residue, and "staining" were found but with no discernable patterns were evident.

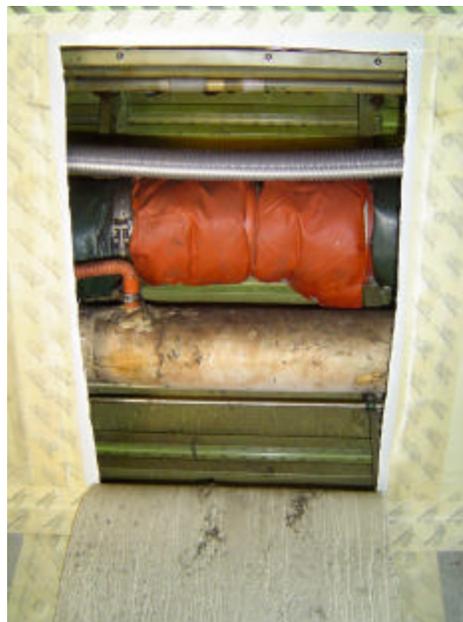
Figure 12: Cheek area in Pit #32.

Various locations of the lower sidewall were examined with the liner removed to expose the space behind it. A section of liner was also removed from the ceiling to examine the area behind it. Upon removal of the liners, staining was found. No fire debris was found in the cheek areas examined and there were no smoke patterns identified. The only debris found was in the form of lint and grime. All the surfaces and components behind the liners were also coated with residue from anti-corrosion agent.

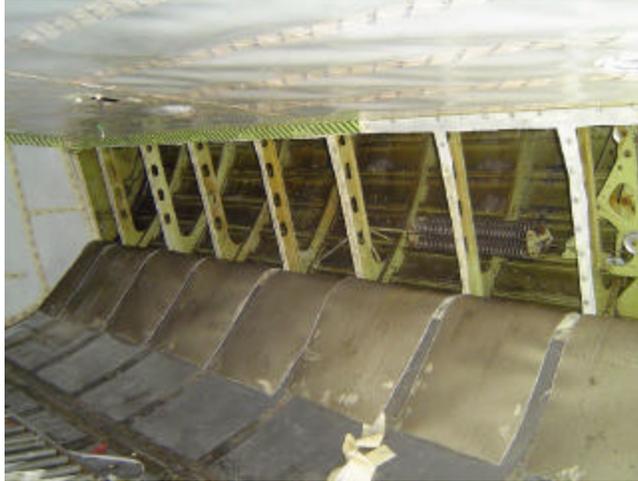
Figure 15: Pit #33 looking forward.

Pit #33 was approximately 50% full of various sized items in cardboard boxes. No sign of smoke or thermal damage was present on the cargo liners. The cargo liner in the cheek area was removed to expose and inspect the structure behind. The structure behind the cargo liner was sooted and small pieces of debris as a result of cargo removal operations from the main cargo hold were found therein; however, it was discovered that solidified aluminum and Lexan drippings existed, which had fallen in from above while still hot and had adhered to the structural components. Examination of the soot deposits revealed heavier sooting towards the forward end of the compartment, with the sooting getting progressively lighter towards the aft portion of the compartment.

During the initial examination, the gill liners in the cheek area of Pit #33 had been removed. The removal of the gill liners had exposed extensive staining of the structural/mechanical components behind them and also the back face of the liner itself. There were also small pieces of fire debris found in the cheek areas behind the liners.

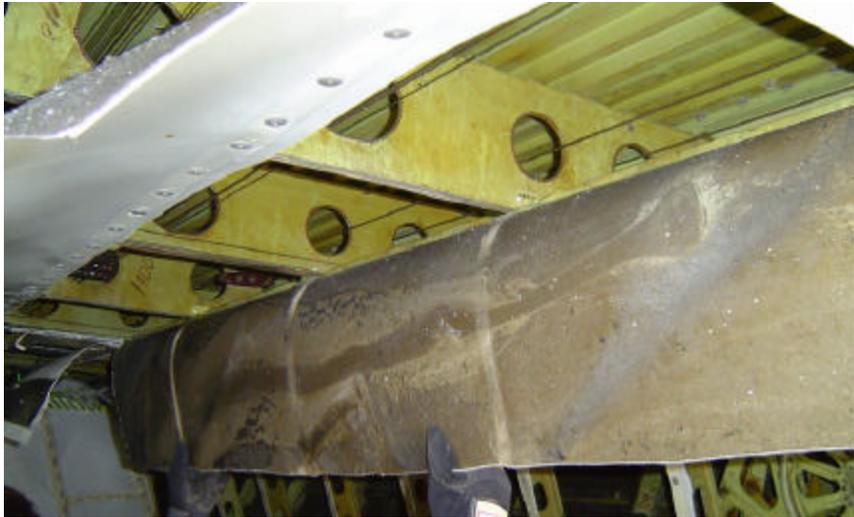
Figure 17: Ceiling in Pit #33

The entire underside of the ceiling was examined and it was found that there was a soot-like stain on all surfaces behind the liners, but with no discernable flow patterns. All the surfaces and components behind the liners were coated with residue from an anti-corrosion agent.
